LYNX Series Bottom Loading Coupler

Installation, Operation & Maintenance
(IOM) Manual

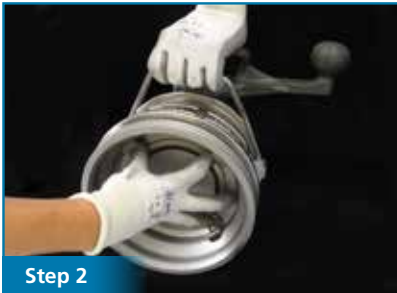
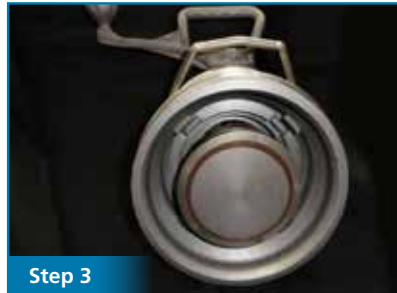
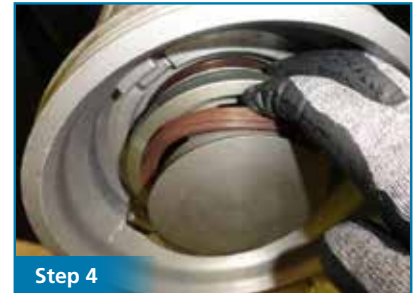
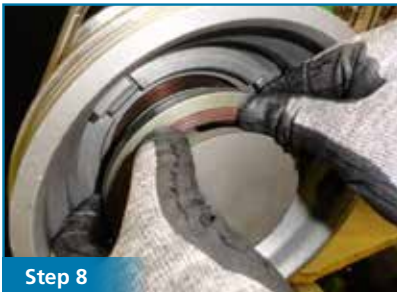
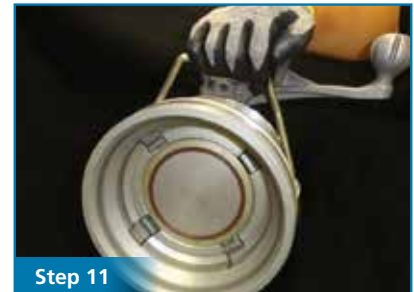
3. Replace Product Seal (API800-1/API800-1VG/API800-1K/API800-1NBR) (IN-SITU)

1. Isolate loading arm to prevent product flow. Drain off fluid in the loading arm and ensure the LYNX is clean and dry.
2. Squeeze the handle (API555-6) and push all four latches in at once. While holding the latches in, slowly release the handle to allow the collar to slide forward.
3. Turn the operating handle (API800-11 or API800-15) to open the poppet (API800-9).
4. Push the poppet adaptor ring (API800-4) back and remove the product seal using a suitable tool ensuring you don't damage the poppet adaptor ring.

8. Push the new product seal into the product seal groove using your thumbs, ensuring the seal is fitted correctly under the groove.

◆ **NOTE:** When installing the product seal, loosely press in 4 places equally around the seal before pushing the seal securely home to avoid uneven compressing of the seal. Ensure the seal's outside edge is in the groove all around.

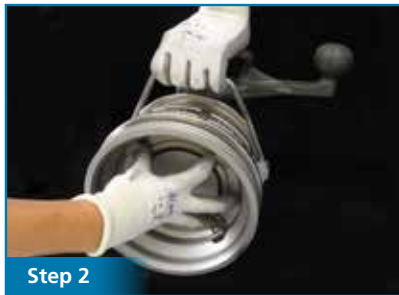
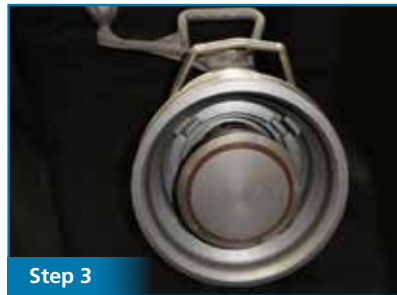
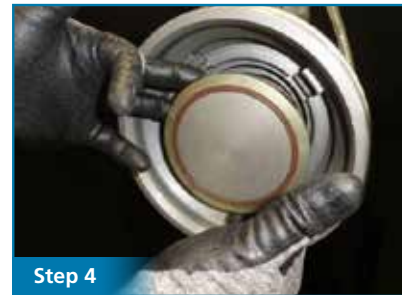
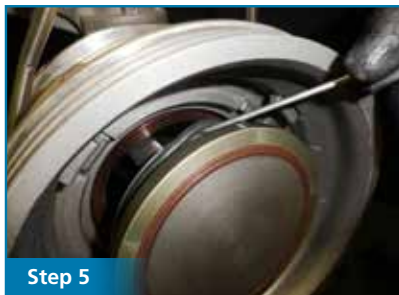
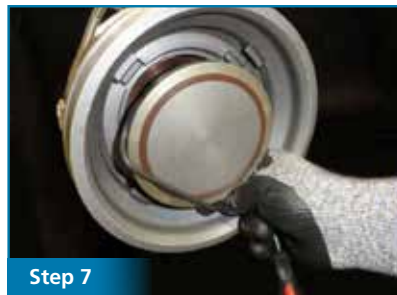
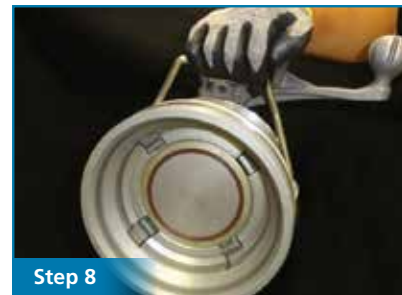
4. Replace Outer O-ring (0203/0203VG/0203K/0203B) (IN-SITU)

1. Isolate loading arm to prevent product flow. Drain off fluid in the loading arm and ensure LYNX is clean and dry.
2. Squeeze the handle (API555-6) and push all four latches in at once. While holding the latches in, slowly release the handle to allow the collar to slide forward.

3. Turn the operating handle (API800-11 or API800-15) to open the poppet (API800-9).
4. Pull the poppet adaptor ring (API800-4) forward.
5. Remove the outer O-ring (0203 or 0203VG) without damaging the poppet adaptor ring.

7. Grease the new outer O-ring using solvent-resistant grease and install the O-ring onto the poppet adaptor ring.
- ◆ **NOTE:** During insertion, minimize O-ring twist and do not overstretch or damage the O-ring. Do not roll the O-ring into place, as this will shorten the life of the O-ring.

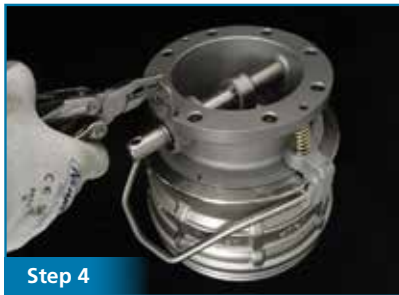
Step 4

1. With the coupler removed from the arm, squeeze the handle (API555-6) and push in all four latches in at once. While holding the latches in, slowly release the handle to allow the collar to slide forward.
2. Turn the operating handle (API800-11 or API800-15) to open the poppet (API800-9).
3. Remove the cap screw (55091) and nyloc nut (4399) using an Allen key and remove the operating handle.
4. Remove U-pin (API800-23) from above the bush assembly using a pair of pliers.

WARNING: Wear safety glasses and remove U-pin with caution as it might spring out when removed.

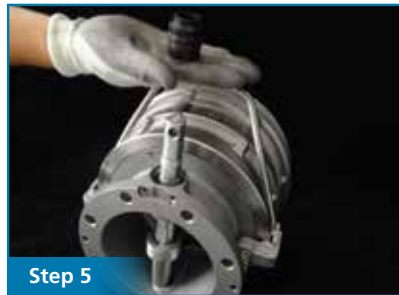
Step 5

5. Extract the bush and O-ring assembly. Tip: Jiggle out the shaft to help extract the bush and O-ring assembly.
6. Remove the bush and O-ring assembly. If the washer comes out, clean it with a clean cloth for refitting as per step 8.
7. Clean the shaft and the bore of grease and debris using a clean cloth.
8. Install the new washer if it came out during step 6. If it did not come out, simply grease the new bush and O-ring assembly well using solvent resistant grease and install the new bush and O-ring assembly, ensuring it clears the U-pin groove.

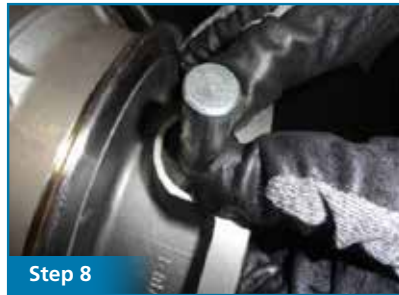
Step 8

◆ **NOTE:** Use your thumbs to push the bush and O-ring assembly into place until it is seated into position and ensure the bore is clean and free from debris.

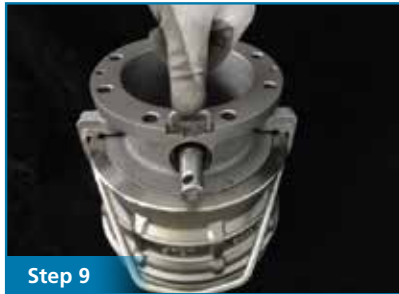
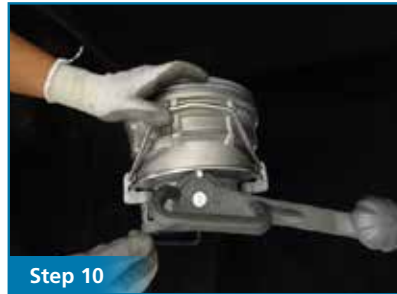
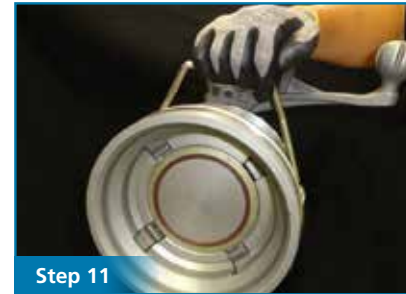
9. Install the U-pin and ensure it is secure.

10. Refit the operating handle as per the orientation shown and refit the cap screw & nyloc nut (4399), ensuring the handle is secured in place by tightening the cap screw/nyloc nut.

- ◆ **NOTE:** 1. Ensure a new nyloc nut is used each time. Do not re-use old nyloc nut.
2. When refitting the handle bolt, the recommended torque is 3-4 N m (this is the torque required to screw through the nyloc nut, but excessive force may damage or strip the nut threads).

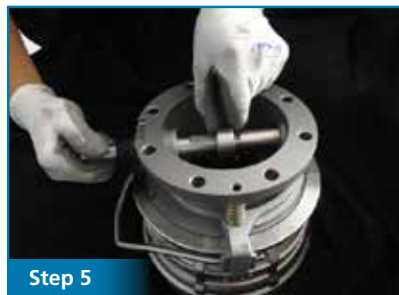
Step 5

5. Hold the eccentric cam (API800-27) so it remains in position without tilting and remove the operating handle and shaft assembly by pulling the handle away from the coupler body.
6. Remove the sleeve from the bottom groove where the shaft sits.
7. Lift the coupler body. The poppet (API800-9) and wave spring (6182) will come out. (Put these aside)
8. Remove the grub screws (3227) using an Allen key.

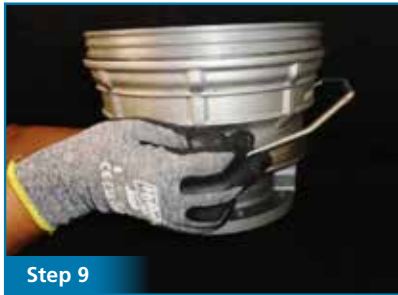
Step 9

9. Turn the unit so the flange faces down and the pins (API800-13) should slide out.
10. Turn the unit so the flange faces up.
11. Remove the springs (4497). If they are damaged, replace them as required.

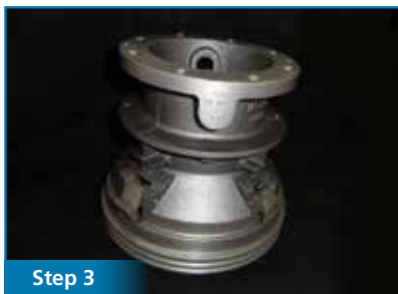
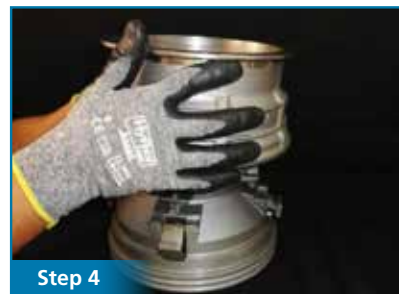
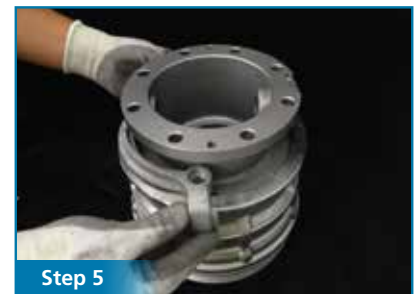
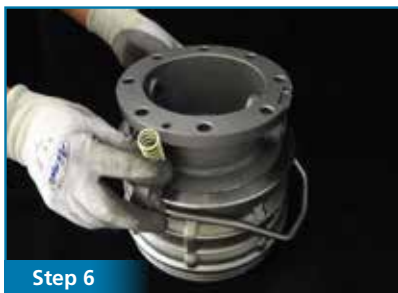
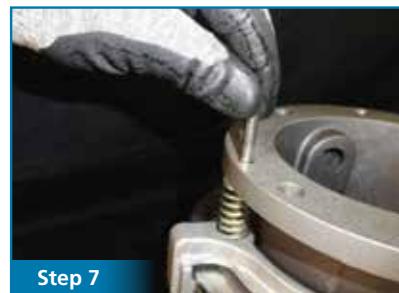
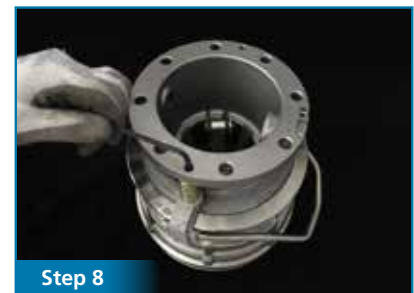
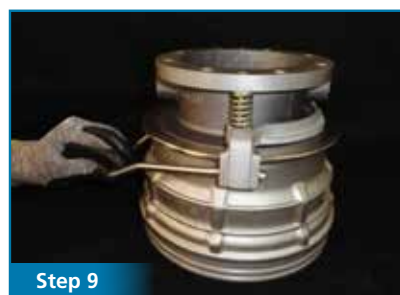
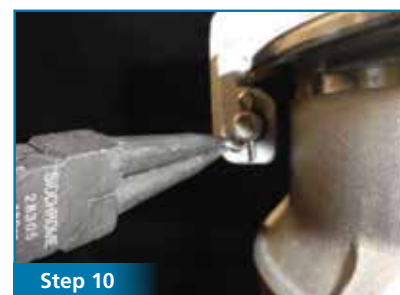
1. Sit body on bench with the flange facing down.
2. If any of the springs (6171) came out during the disassemble procedure, inspect them for wear and replace as required. Refit the springs into the drilled holes in the body.

4. Place the collar over the body. Ensure all latches are pressed in so that the collar drops flush with the front face.
5. Place lever (API555-10) on the bottom of the coupler as per the orientation shown below.
6. Place springs (4497) into the recess of the lever, lining them up with the holes for the grub screws.

7. Place pin springs (API800-13) into the holes of the coupler body.
8. Fit the grub screws (3227) and tighten with an Allen key so they sit below the surface of the coupler body.
9. Fit the latch release handle (API555-6) into the lever (API555-10) ensuring it is in the correct orientation as shown in the step 9 image.
10. Fit the split pins (0762) into both ends of the handle and secure by bending the longer end of the pin over (as shown in the step 10 image).
11. Replace seals on poppet adaptor ring in line with instructions in Section 3 – Replace Product Seal (page 8) and Section 4 – Replace Outer O-ring (page 9).

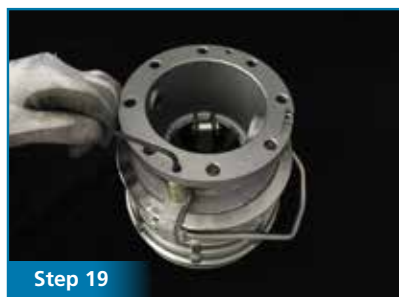
Step 19

19. Refit the operating handle (API800-11 or API800-15) as per the orientation shown in the step 19 image on page 17 and refit the cap screw and nyloc nut (4399), ensuring the handle is secured in place by tightening the cap screw/nyloc nut.
- ◆ **NOTE:**
 1. Ensure a new nyloc nut is used each time. Do not reuse old nyloc nut.
 2. When refitting the handle bolt, the recommended torque is 3-4 N m (this is the torque required to screw through the nyloc nut, but excessive force may damage or strip the nut threads).
20. Close the coupler operating handle and pull back the latch release handle allowing the collar to retract and click into place.
